Heritage Structural Preservation

Liao Haixue, P.E. (NY), P.Eng. (ON),
Vector Corrosion Technologies

Concrete and Corrosion Evaluation Defines the Scope of Structural Repairs Required.

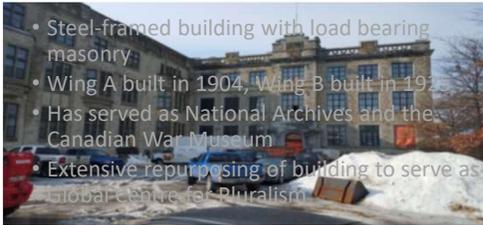
The Global Centre for Pluralism – 330 Sussex Dr, Ottawa

- Steel-framed building with load bearing masonry
- Wing A built in 1904, Wing B built in 1975
- Has served as National Archives and the Canadian War Museum
- Extensive repurposing of building to serve as the Global Centre for Pluralism

- Corrosion identified on beams and columns embedded in masonry walls
- With current wall assembly, very difficult to eliminate moisture in the walls

- Install small anodes within the wall assembly to mitigate corrosion at beam ends
- Encase beam ends in concrete to ensure that the entire beam end is protected

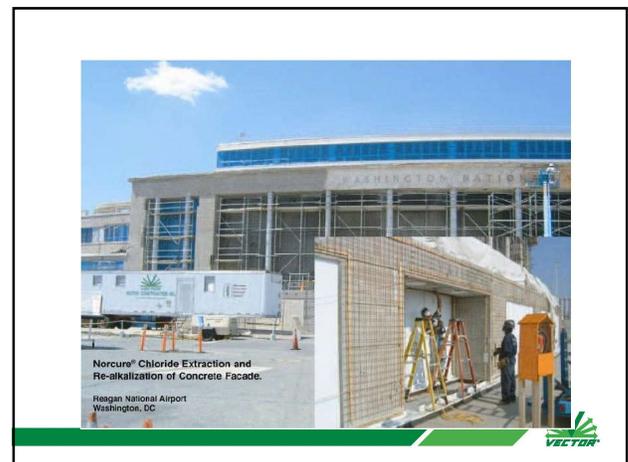
Realkalization Installed

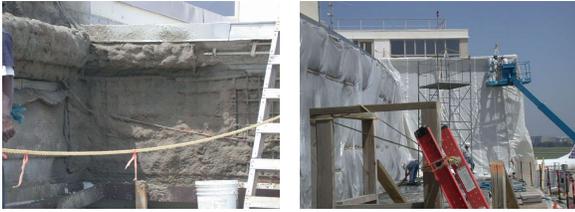
- Realkalization media is a paper mache material that is saturated with an alkaline solution.

- Cover zone impregnated with high pH solution
- Low alkalinity rectified
- Entire surface treated
- Life of structure is extended
