Conservation of a 100-year old steel reinforced lime-concrete system in a Class-I heritage building using galvanic anode cathodic protection

Radhakrishna G. Pillai, Deepak Kamde, Naveen Krishnan, Karthikeyan Manickam, Keerthi V Thalakkal, and Ananya Ajayan

National Centre for Safety of Heritage Structures (NCSHS)
Department of Civil Engineering
Indian Institute of Technology Madras
Chennai, India

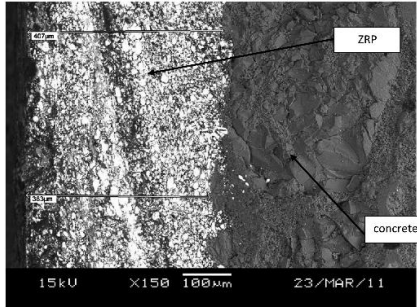
Cathodic protection – Zinc coating on concrete surface

Labels: ZRP, concrete

About 400 μm thick coating

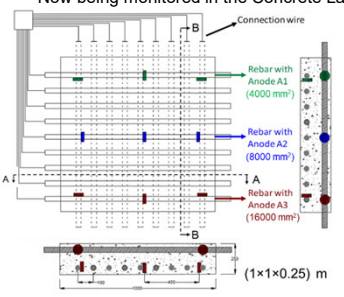
Laboratory study – Four 12-year-old slabs

- Specimens were cast by Dr. George Sergi of Vector Corrosion Technologies (about a decade ago)
- Now being monitored in the Concrete Lab at IIT Bombay

Labels: Connection wire, Rebar with Anode A1 (4000 mm²), Rebar with Anode A2 (8000 mm²), Rebar with Anode A3 (16000 mm²), (1x1x0.25) m

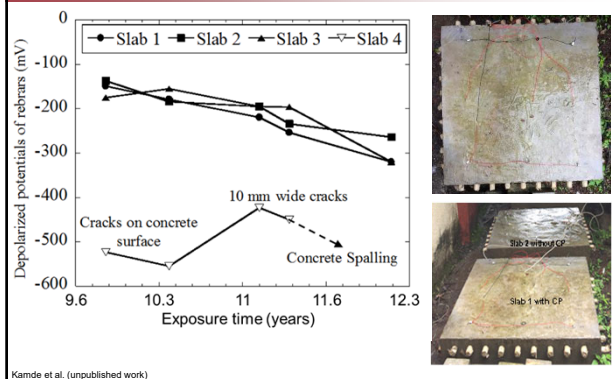
Depolarized potentials - at the end of 12 years of exposure

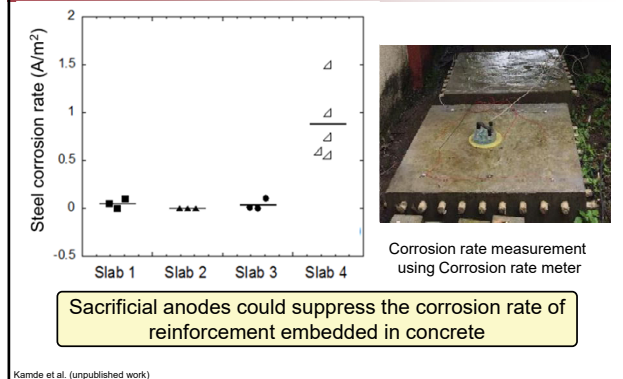
Steel corrosion rate - at the end of 12 years of exposure

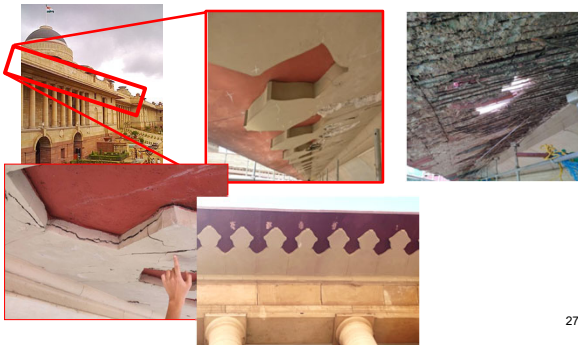
Corrosion condition

Before delamination survey

After

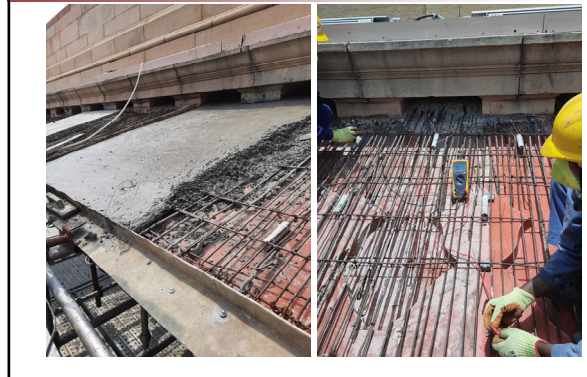
Photos during and after repair

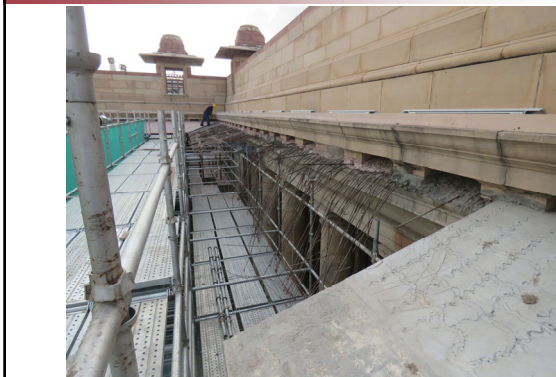
Photos during and after repair

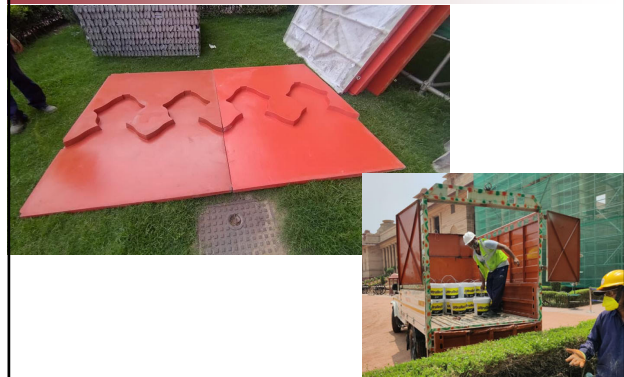
Photos during and after repair

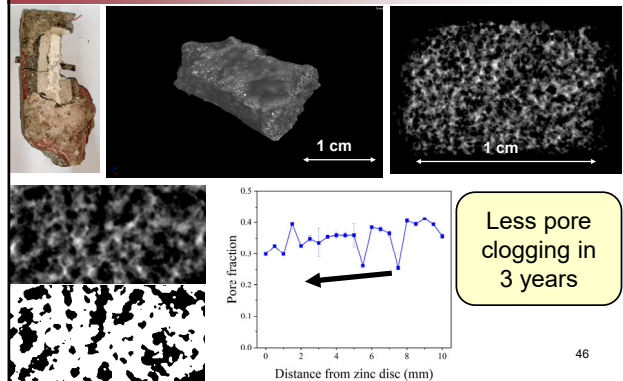
Evolution of porosity in 3 years

Less pore clogging in 3 years
